Volume 51. March 1937. $4.00 a Year.
Number 1. Pages 1-130. $1.25 a Number.

JOURNAL

New England Water Works Association.

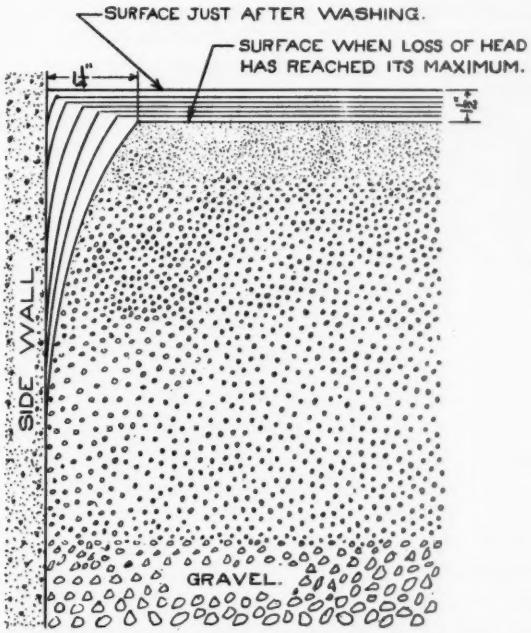
Pulling Away from Sidewalls. There are not many filter beds that do not pull away from the sidewalls. In some plants the pulling away is little, and trouble resulting from such cause is not great. Many beds, however, pull away to the extent that this is a contributing cause to much of the clogging which develops. It is not uncommon to find filter beds that have

FIG. 2.— CRACKS ALONG SIDEWALLS OF FILTERS.

pulled away from the sidewall as much as one inch at the top of the bed by the time the maximum loss of head is reached. Sidewall cracks, in some instances, have been found to extend to a depth of 18 in. from the top of the bed in filters having a total sand depth of 24 in. This is three-fourths the depth of the bed. The depth of such cracks has been determined by pushing a thin sheet of iron down along the sidewall, or by digging the sand away and observing the depth to which there is side filtration. The formation of a layer of mud similar to that at the surface enables the depth of pulling away to be determined with considerable accuracy.

scale is greater than the vertical scale in order to show the pulling away more clearly. The depth to which the crack penetrates is somewhat in proportion to its width at the top of the bed. A crack ¼ in. wide at the top may extend 4 to 8 in. below the surface, but not 16 to 18 in.; likewise a crack 1 in. or more in width at the surface will extend downward more than one-half the depth of the bed.

Maintenance of filter beds in a condition which will almost prevent sidewall cracks requires them to be kept much cleaner than is possible by washing the beds with backward flow of water, though a very high rate of backwash is better than a rate of 15 g.p.m. per square foot. The high rate of washing is discussed in another section of this paper. The surface wash, which also will be described in another section, appears to be the only means of keeping filter beds as clean as is necessary to prevent sidewall cracks.

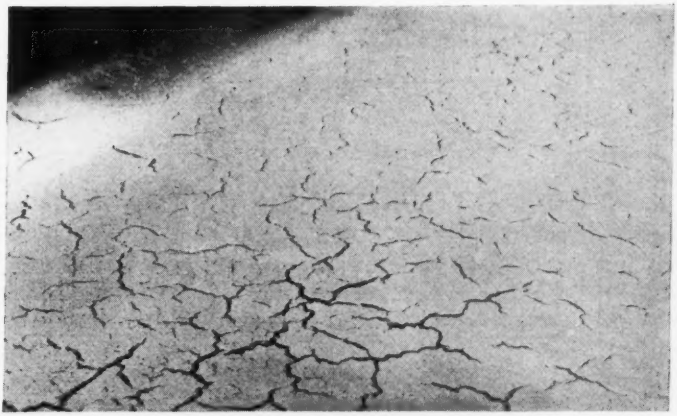
service. Settlement of the beds contributes to certain filter bed troubles, for it allows beds to pull away from the sidewalls and at times permits cracks to open somewhat as shown in Figure 3.

FIG. 3.— SURFACE CRACKS IN A FILTER BED.

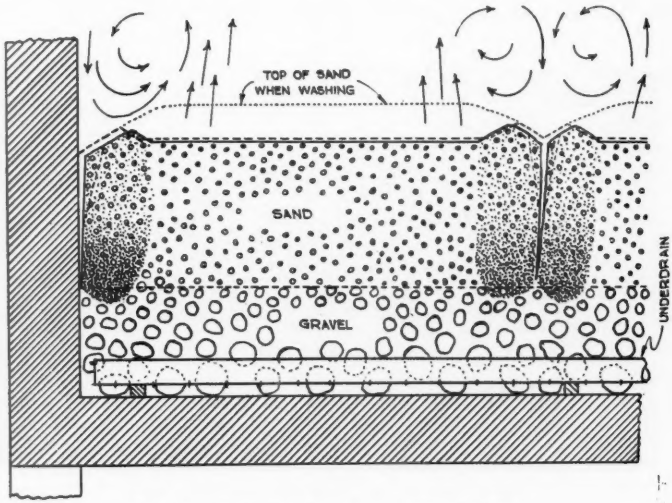
Figure 4 shows both typical sidewall clogging and clogging in another part of the bed. In this instance the sidewall clogged mass rests upon the gravel and does not adhere to the filter sidewall. It pulls away from the sidewall as the loss of head increases, sometimes opening a crack directly to the gravel. There is some side filtration through the clogged mass, especially in the upper part. The sand in this part usually is not badly clogged, though it is not disturbed during the washing, *i. e.*, it is not expanded like the rest of the sand. There may be a very gradual displacement of this sand. The clogged mass moves back against the sidewall during the washing period, and pulls away as the loss of head increases on the filter. Perhaps it would be more correct to say that it is pushed away, for there

Much study has been given to the manner in which clogged areas form. First there must be an accumulation of mud or mud balls in the filter. This almost invariably causes pulling away from the sidewalls of the filters, though it is true that there would be considerable clogging without the sidewall cracks. Certainly the pulling away aids greatly the formation of sidewall clogged areas similar to that shown in Figure 4.

FIG. 4.— CLOGGED AREAS IN A FILTER BED.

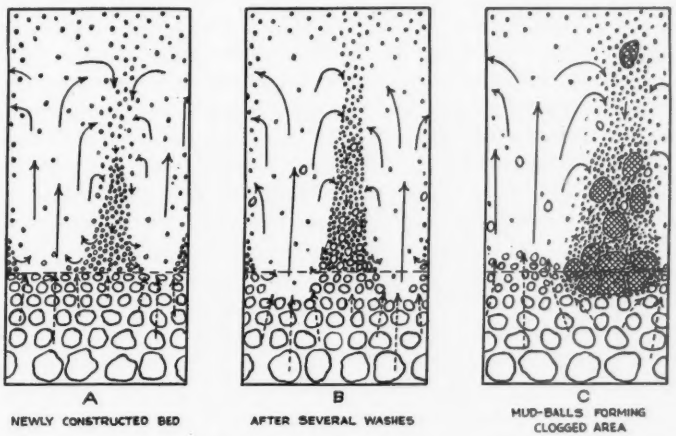
When the specific gravity of the mud balls becomes great enough to cause them to settle to the bottom of the sand or other filtering material, they may be piled up in certain points by the jets, and become mashed together to the extent that they adhere and start the formation of clogged places. Filters with little or no surface indication of clogging have been found to possess an almost endless meshwork of clogged places, or pockets

FIG. 8.— JET ACTION AT THE SAND-GRAVEL INTERFACE.

of mud, at the gravel surface. The assistance given by jet action in piling up mud balls at certain points in filters probably is responsible for most of the clogged places not along the sidewalls of filters.

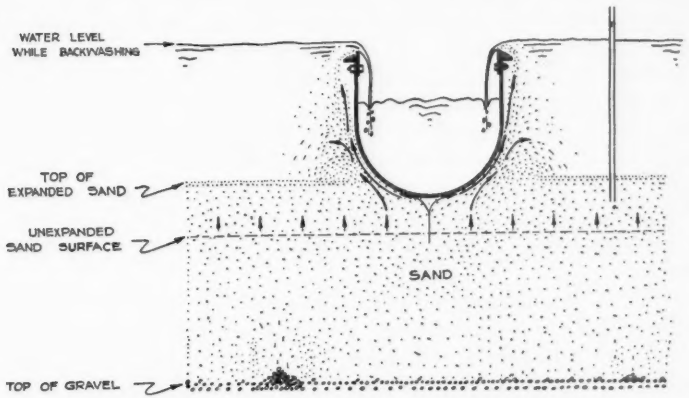
The reason why sand may be thrown so high up into the water at certain points may be explained by Figure 9. Considerable velocity is

imparted to some of the water coming from underneath the wash water troughs where the troughs extend below the top of the expanded bed, and the wider the troughs, the greater is the amount of water which must escape around the troughs. Very high rates of washing require larger troughs to take away the wash water, and the tendency in design is to make the troughs both wider and deeper. The distance from the top of the beds to the top of the troughs has, in some instances, been increased, though not enough to prevent loss of sand at very high washing rates. Consequently, when the filter is washed, part of the underside of the troughs may be several inches

FIG. 9.— CROSS-SECTION THROUGH FILTER SHOWING LOSS OF SAND DURING BACKWASHING.

below the top of the expanded sand. It does not seem desirable to raise the wash water troughs much more than 30 in. above the sand.
